Chesapeake Bay Stewardship Fund

Interim Programmatic Report and Payment Request – September 30, 2014

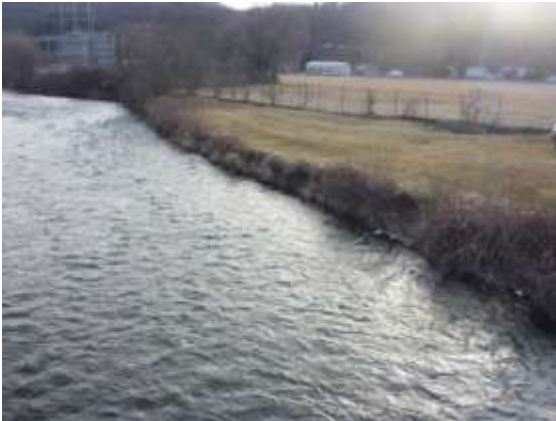
**Lower Milesburg Project – 2012 Before
Note –Step Bank, No Plant, mowing to edge**

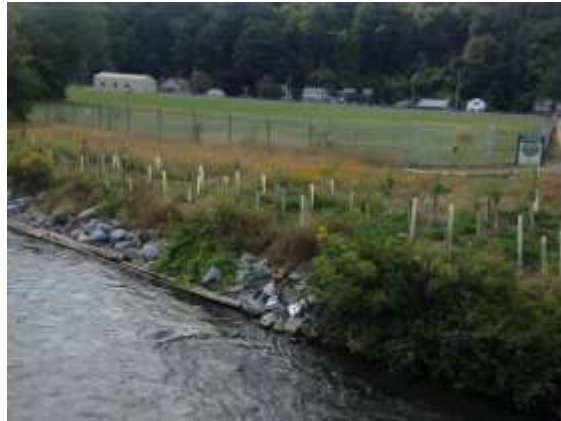
**Lower Milesburg – September 2014
200” Mudsill protecting bank, native trees and shrubs, wildflowers and interpretive sign.**

a. **Lower McCoy** – Project has been expanded and has been completed. All of the final plantings at the site are complete including the wild flowers. This includes a total of four in-stream multi-log vane diverters, a 200' mudsill, riparian plantings of native trees, shrubs, and wildflowers. We also had to amend the upper structures at the site. After several major storms, the multi-vane log deflectors were determined to be inadequate to stop all of the erosion. Working with Pennsylvania Fish and Boat Commission, we were able to install coir logs between the deflectors and plant willow stakes. This effort was successful.

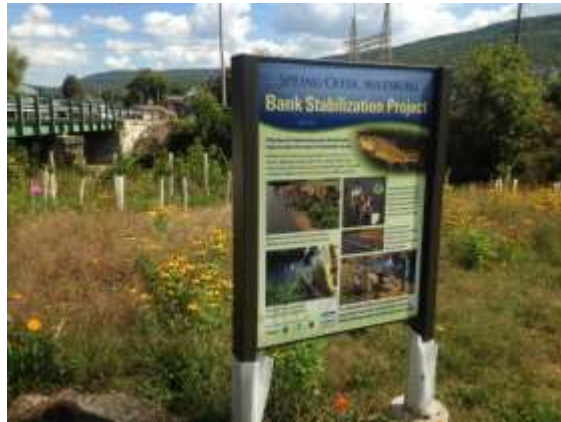
Picture of the interpretive sign and wildflowers

The interpretive sign was completed and installed by a volunteer local construction company. (See Pictures Attached 5-A)

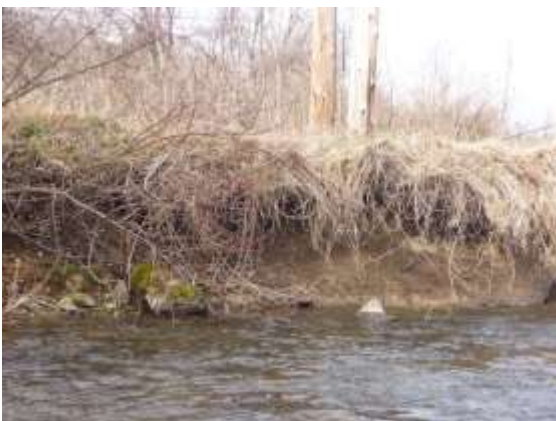
Upper Milesburg Erosion

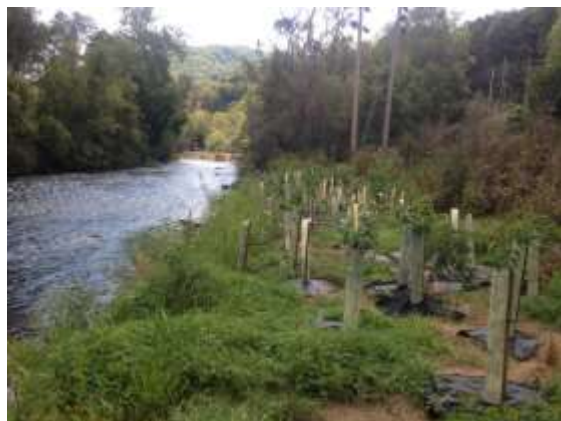
Upper Milesburg – After 4 multi-vane log deflectors, coir log, and riparian planting.

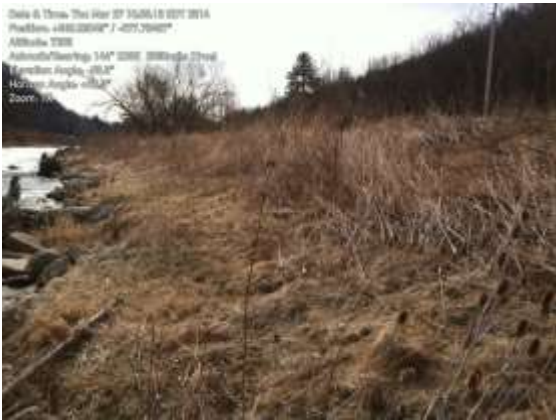
McCoy Planting Area – Before Plantings

In addition, a significant planting at the McCoy Site on the west side of Spring Creek was undertaken and completed. This ½ mile reach had never been planted due to railroad right of way issues and wetland issues. We were able to obtain transport for our personnel (total of 68 volunteers) and material via the local volunteer fire department's rescue boat. This allowed us to work with 7 other agencies to obtain and plant some 1750 native shrubs and trees along the site. The organization is performing maintenance at these sites and our survival rate is around 95%. (see Pictures Attached 5- B)

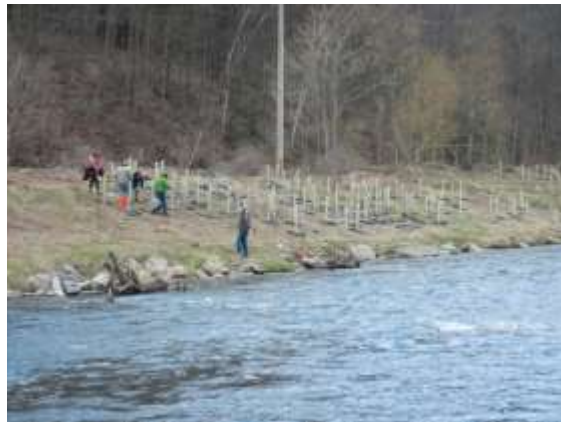
McCoy planting – during the planting. ½ miles of total stream with 1750 native plants & shrubs

- The plantings at the McCoy site have a 95% survival rate. This has resulted in a 35’ to 75’ buffer that has stabilized the bank along a 2000’ reach. With the survival and maturing of the 1750 native trees and shrubs, a significant increase in the canopy will be achieved.

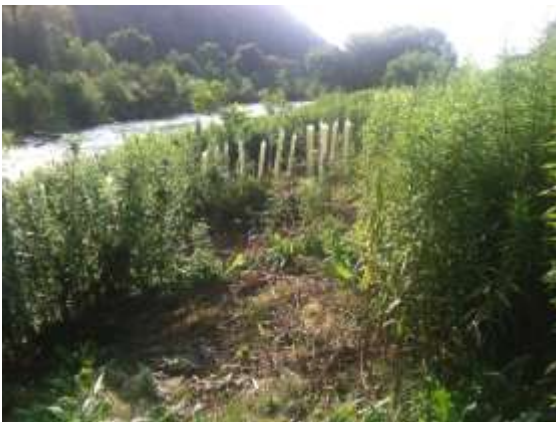
McCoy planting – clearing out the weeds to help them to grow – 95% survival rate.

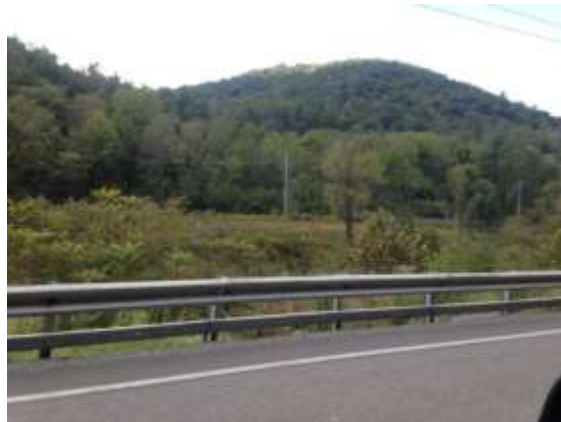
McCoy Planting – picture from September 2014

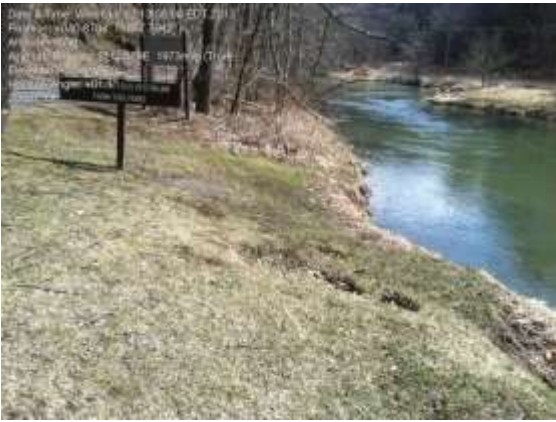
Fisherman's Paradise – Before diverter

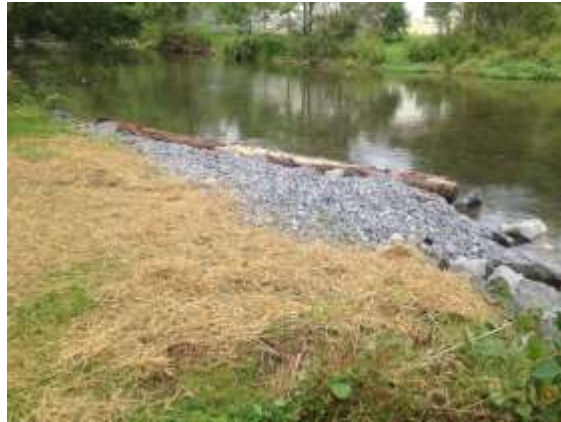
Fisherman's Paradise – After diverter

- The parking lots and in-stream structures have been installed at Fisherman’s Paradise. The installation of three multi-vane log deflectors has improved the stream flow, thereby reducing the accumulation of silt in the stream bed and reducing the erosion in the area. It improved grading and permeable surface, along with the construction of swales, has virtually eliminated the effects of stormwater from the parking lots and roads. In addition, the installation of 6x6” posts on the perimeter of both of the parking lots, has eliminated destructive parking practices in the immediate area.

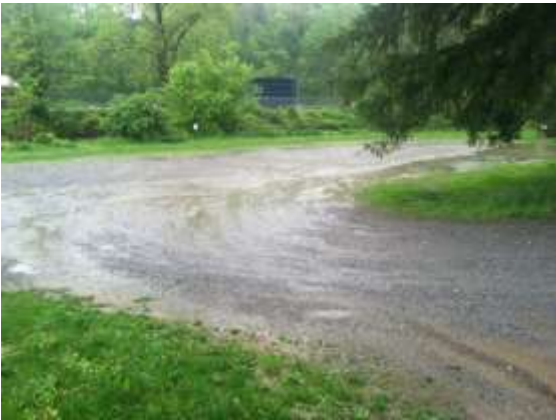
Fisherman's Paradise – Upper Parking Lot

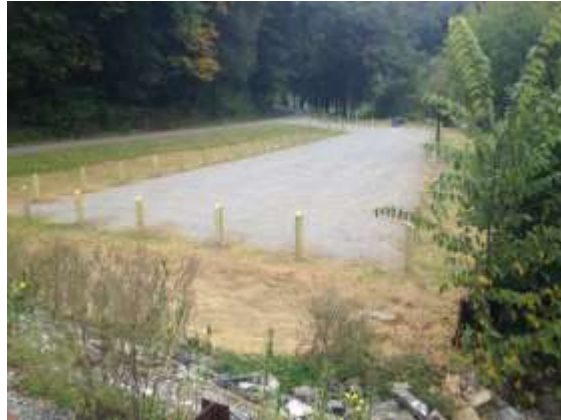
Fisherman's Paradise – Upper Parking lot stormwater diverted to swale at bottom

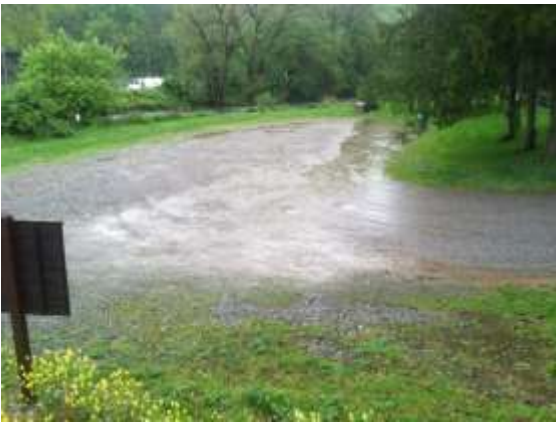
Fisherman's Paradise – Lower parking lot.

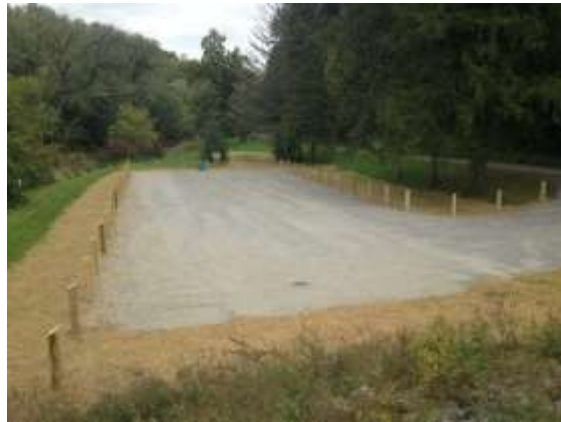
Fisherman's Paradise – Lower parking lot. Stormwater diverted to swale on right away from creek.

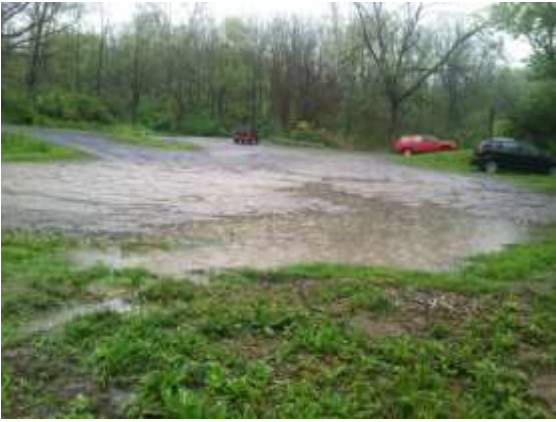
Rock Road Before Improvements

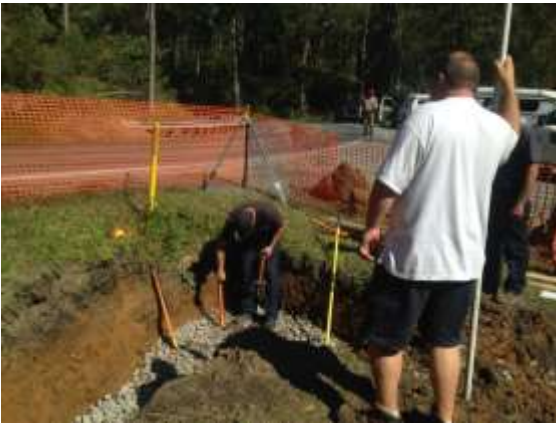
Building the diverter

c. **Rock Road** – All construction on the parking lot and swales has been completed. This project included installation of a pipe diverter to take water running under Rock Road via a culvert and pipe it along side of the re-leveled parking lot to an excavated swale next to the wetlands. In addition, the parking lot was re-graded to tilt back towards Rock Road so that the stormwater would flow into the swale. Finally, wooden posts were installed to discourage dumping and malicious driving in the area. A small amount of riparian plantings will be undertaken in the Spring of 2015. (See pictures attached 5-D).

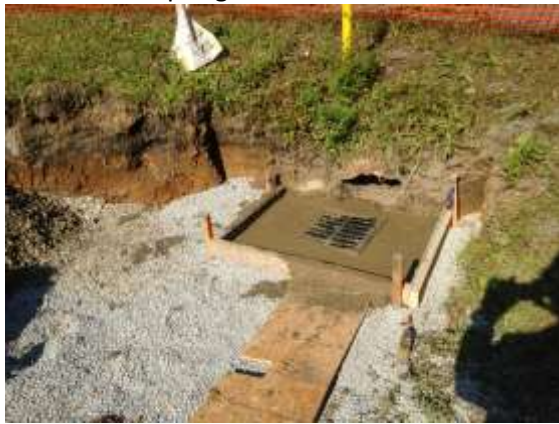
Stormwater enters grill and is piped to wetlands

- The parking lot and stormwater diversion structures are installed at Rock Road. The effect of this is to significantly reduce the effects of a serious stormwater problem. The parking lot is located at the bottom of a canyon with Rock Road coming down the canyon and turning to parallel the stream. Installation of a pipe to divert the culvert under the road to a swale and wetlands, and grading the parking lot to move the stormwater to the swale has virtually eliminated the impact of the stormwater. In addition, the parking lot is a permeable surface that moves the stormwater to the swale. Construction of 6x6” posts along the perimeter of the parking lot has eliminated significant destructive parking practices in the area.

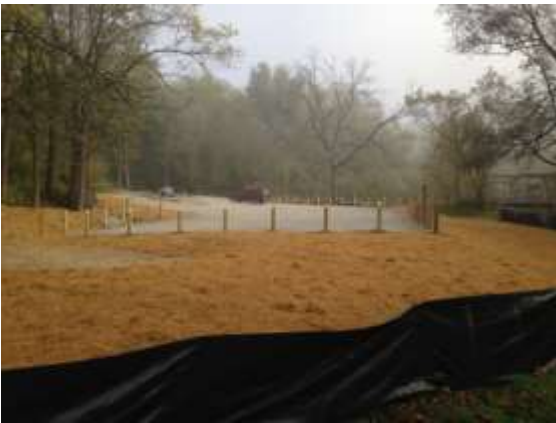
Picture from wetlands back toward Rock Rd.

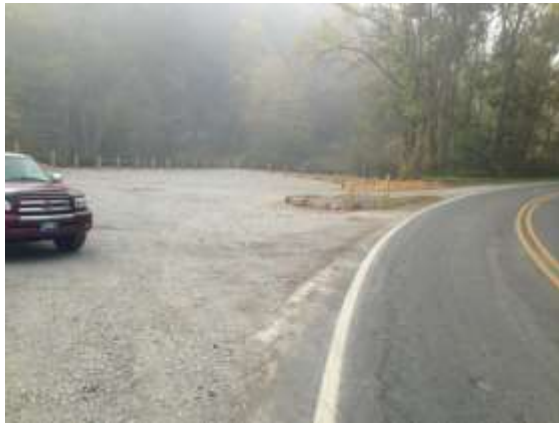
Parking lot picture from Rock Road.
